Manhole Inspection Summary

Manhole # S51C__004MH

Inspection ☐ Is Incomplete Rating: **3) Fair**

Location Address: **101 n streeper st** Cross Street: **e fairmount ave**

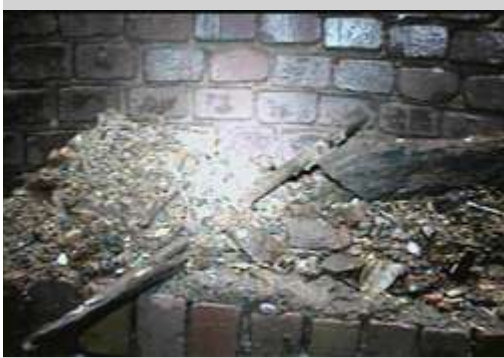
Defect 2

Condition: ☐ Sound ☐ Cracked ☐ Root Intrusion ☐ Deteriorated ☐ Leaks ☒ **Debris**

bench debris

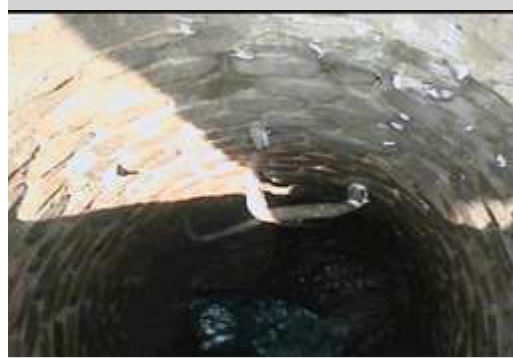
Defect 1

Steps Count: **6** Missing: **1** ☒ **Corroded**

steps

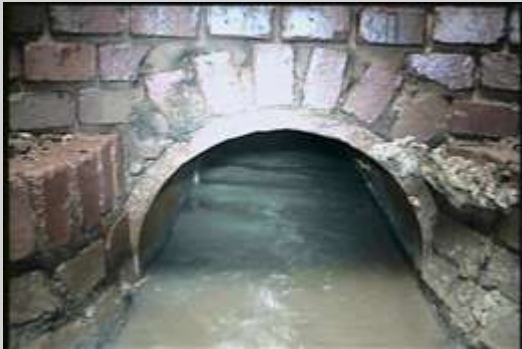
12 O'Clock Outflow

15 in. Circular Gravity Sewer
Pipe Out @ 12 O'Clock

Infiltration: **None** Pipe Seal Cond: **Unknown**

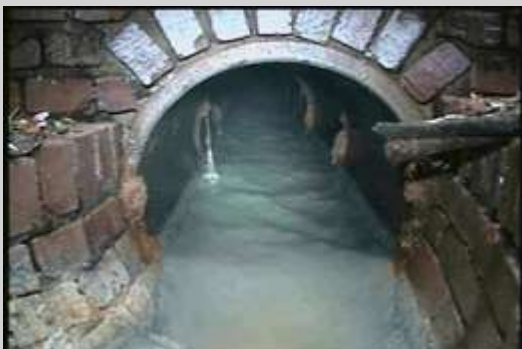
3 O'Clock Inflow

15 in. Circular Gravity Sewer
Pipe In @ 3 O'Clock

Infiltration: **None** Pipe Seal Cond: **Unknown**

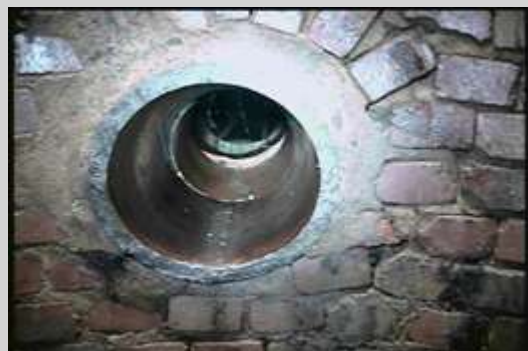
9 O'Clock Inflow

Pipe In @ 9 O'Clock

Infiltration: **None** Pipe Seal Cond: **Unknown**

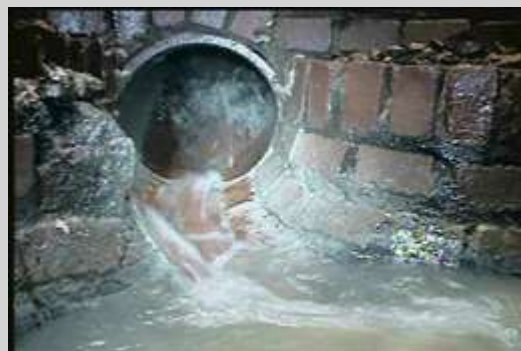
Drop In @ 9 O'Clock

Drop: **Outside Direct**

Drop Condition: **Open**
